INTERGOVERNMENTAL STANDING  
COMMITTEE ON SHIPPING

Report on the  
Assessment of Level of Service Delivery Across the  
**Inland Waterways in the Facilitation of Shipping  
and Trade on Lake Victoria**

April 2022

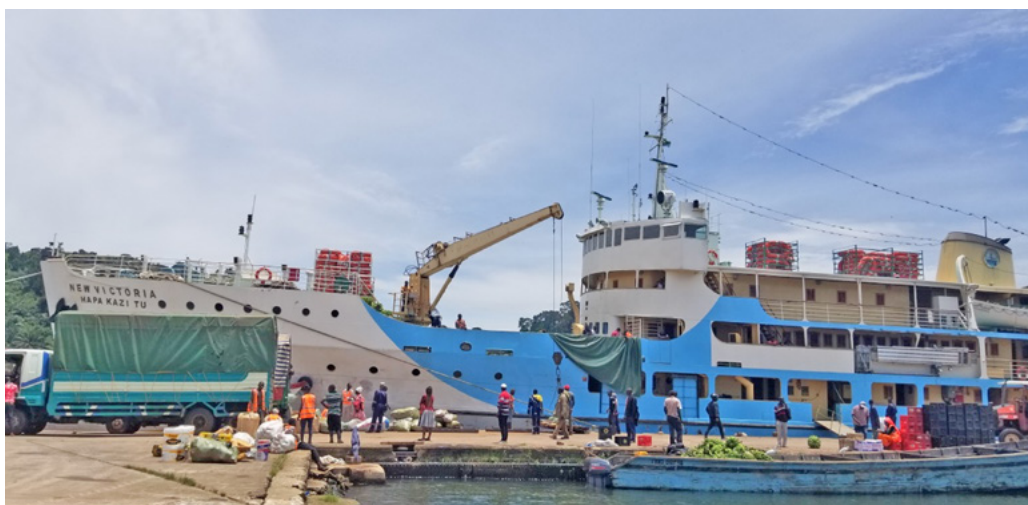
Figure 5: MV New Victoria (self-loading) at Berth in Bukoba Port

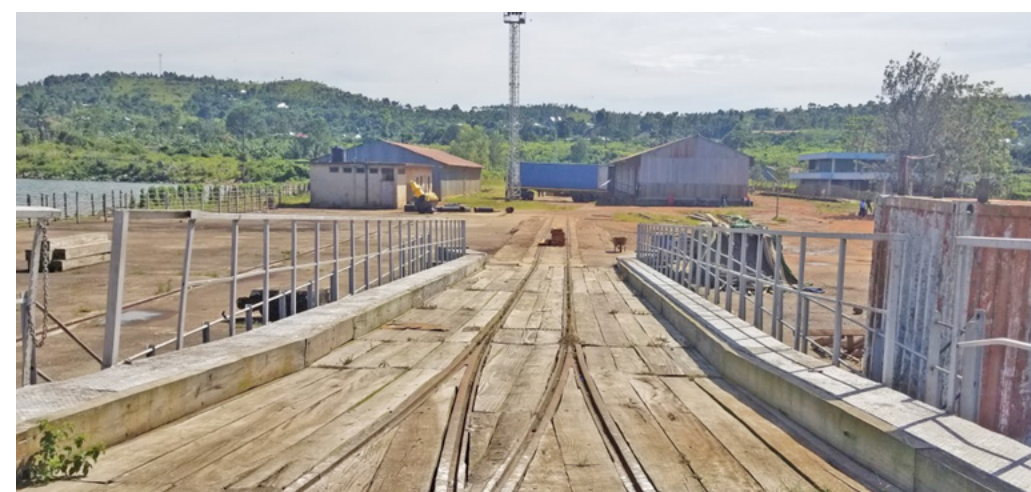
Figure 7: Outlook at the Kemondo Bay Port Yard seen from the Linkspan

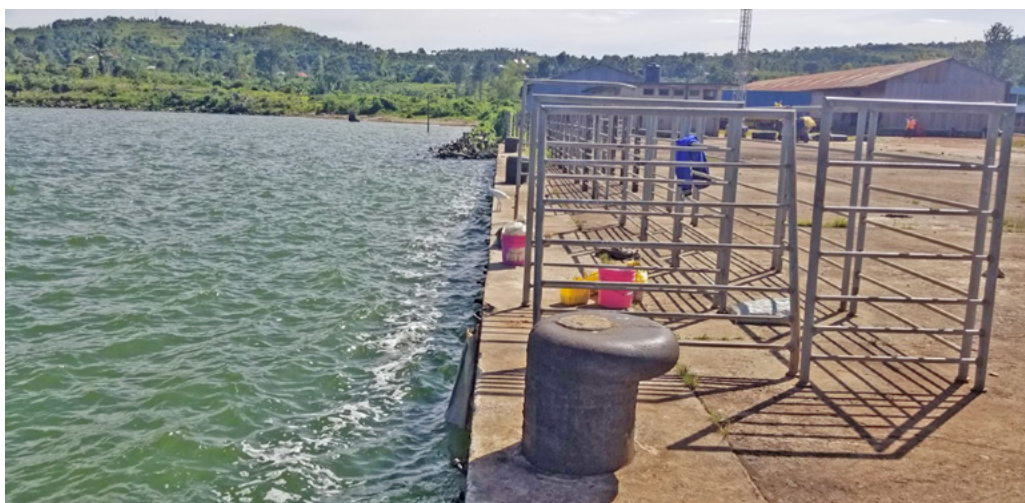
Kemondo bay had three berths with quay lengths of 70m, 22m (adequately designed to handle live animals) and 37m respectively with average draught of 4.5m; all in good condition with a separate jetty (about 100m away from the main berths) for handling vessels of traditional build. There was a good shed and five sheltered warehouses at the port with two in use while the rest were in disuse due to limited cargo to handle.

Figure 8: Berth for handling live animals at Kemondo Bay

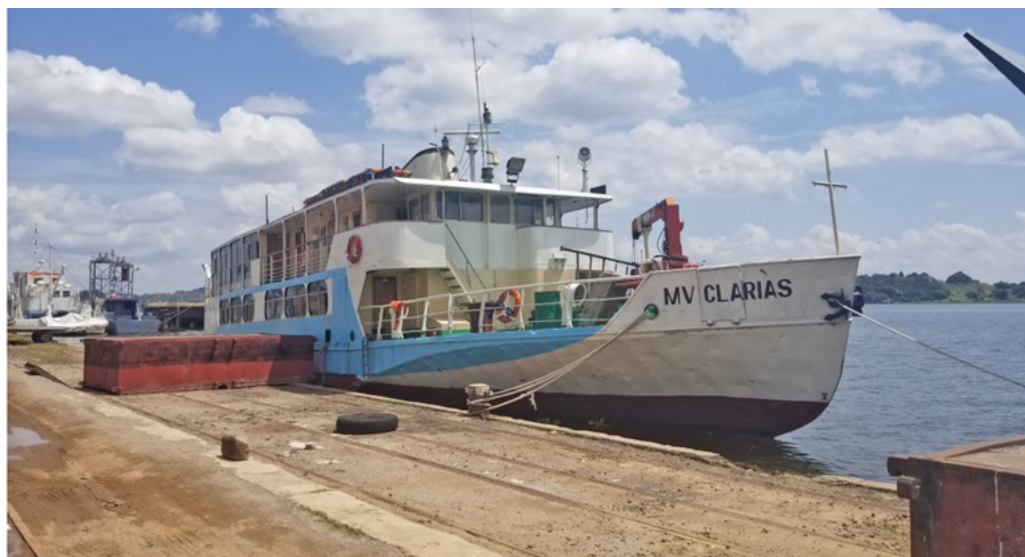
Figure 11: Stepped quay apron at Mwanza South

Some part of the quay apron was constructed on a two tier level with a difference of 0.7m in height over a length of 190m. The upper level fronting the cargo and transit sheds was some 7m in width and this reduces the effective working area on the quayside to some 5m in width, greatly hindering horizontal transfer operations. At the northern end of the quay, some 60m of the apron had recently been modified raising the apron to similar levels and at the time of this exercise this area was being used as a docking and maintenance wharf and providing hard-standing storage and yard space.

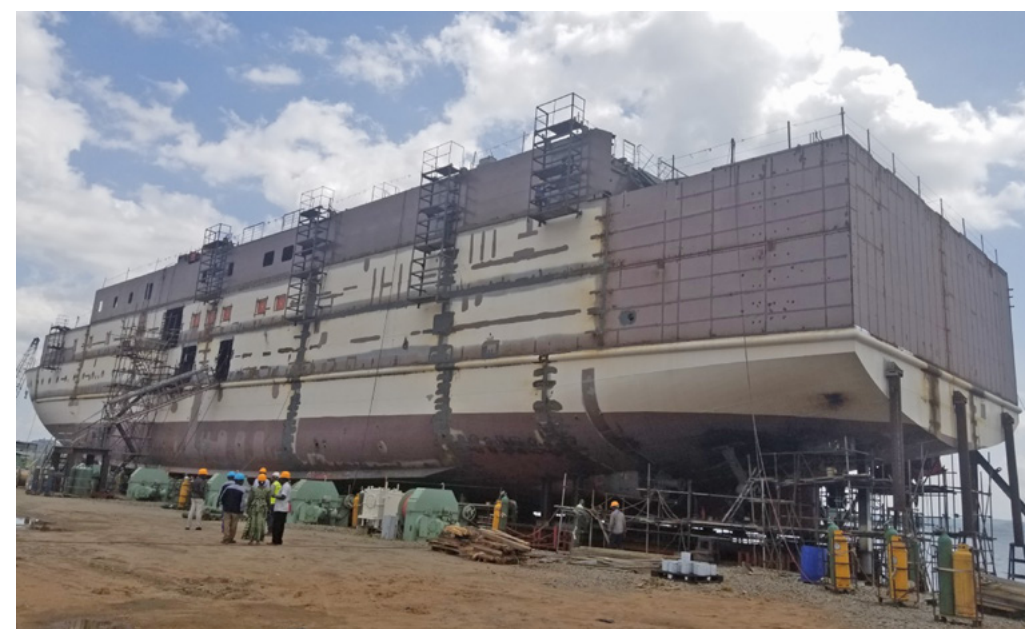
During the time of the visit, MV Mwanza (New ship of 1,200 passengers and 300tons cargo capacity) was under construction on the slipway while MV Umoja the wagon ferry was undergoing major rehabilitation.

Figure 13: MV Mwanza under construction at a slipway in Mwanza South

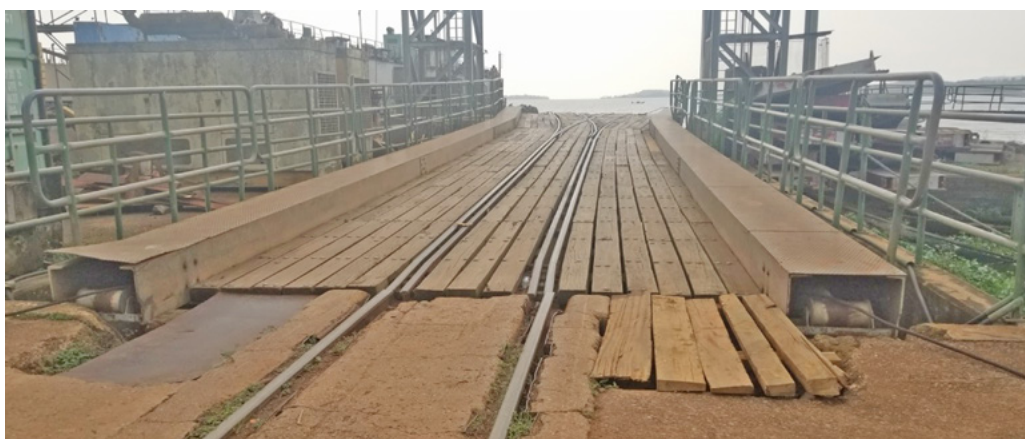
Figure 15: Linkspan at Port Bell

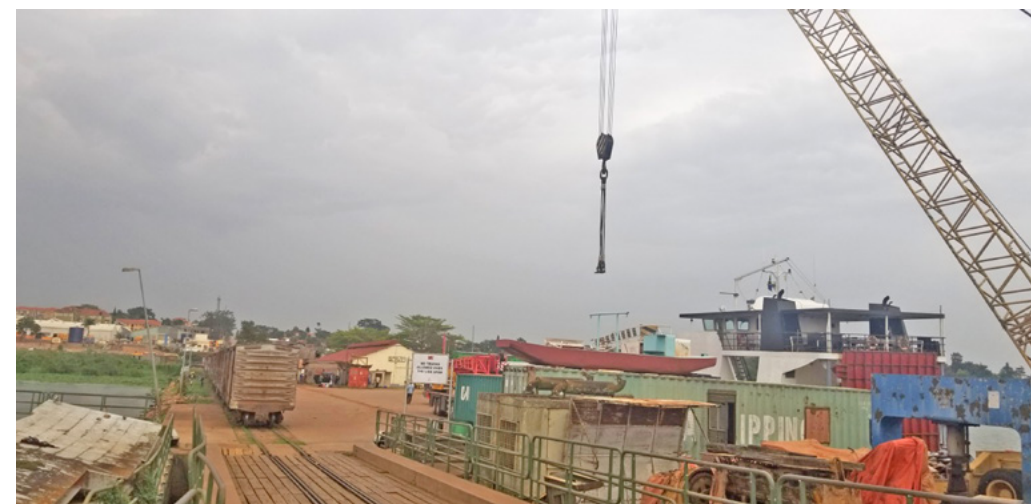
The port had a 2,000ton capacity dry dock but didn't have any cargo handling equipment with stevedoring being manually done. Lighting in the port was not sufficient making it difficult to operate at night and there was no standby generator. There was no radio communication system installed with all communications done by mobile phones.

Figure 16: Port Bell Outlook as seen from the Linkspan

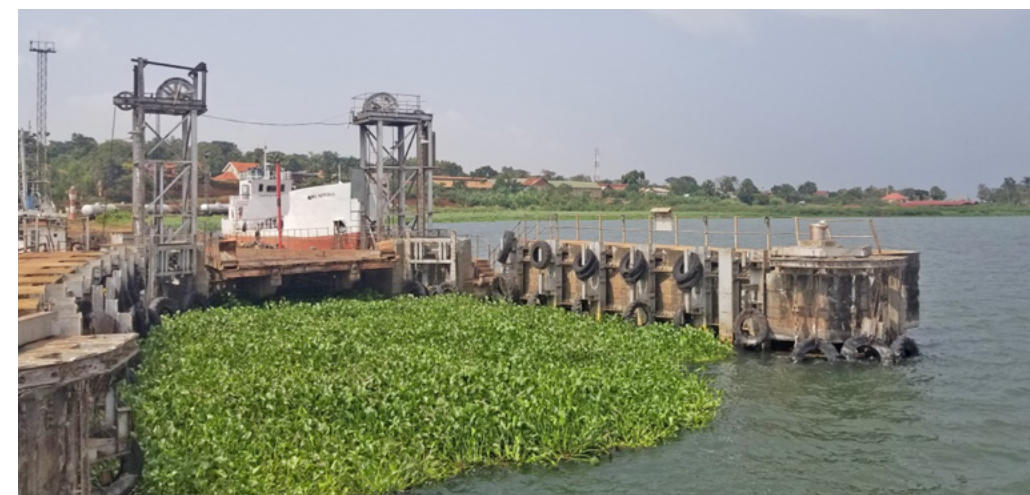
Figure 18: Linkspan guide walls with worn-out fendering

The linkspan was in bad condition with floor timber structures evidently missing or worn-out which was a health hazard. The linkspan hoist tower winches required urgent service and the fendering system was in poor shape with missing fendering tyres, timber and fender holding chains and hooks. The guide walls didn't have any fendering and the berthing dolphin on which tag men operate from (guiding the vessels in/out) was leaning over indicating a failed structure. Some sections of the walkway to the dolphin were missing guardrails and there were no lights throughout the port meaning operating at night was very big risk.

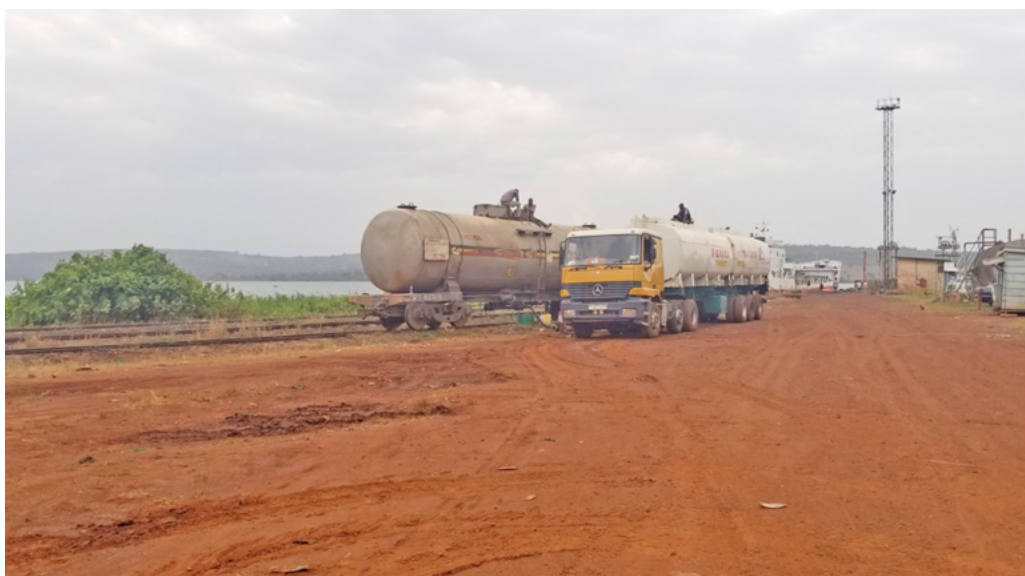
There was no standby generator and the port neither had a firefighting plan nor did it have equipment like fire extinguishers and trained officers for the same. It was evident that there were acute shortages of shunting locomotives which meant that loading and offloading of wagons would take longer than necessary.

Figure 19: A truck drawing fuel from the wagon tank at Jinja Port due to lack of shunting locomotives

It was reported that a siding had been installed to one of the port's major clients Bidco Uganda Ltd manufacturing edible oils and soaps in addition to an existing siding to the Bulk Grain Handlers (Engano, Kengrow, Master grain, etc) which was expected to increase the port's throughput but required some remedial works to be done at the port and acquisition of additional locomotives for shunting to support such businesses.
