**INTERGOVERNMENTAL STANDING
COMMITTEE ON SHIPPING**

REPORT ON THE SURVEY OF THE

DAR ES SALAAM TRANSIT AND TRANSPORT CORRIDOR

October, 2022

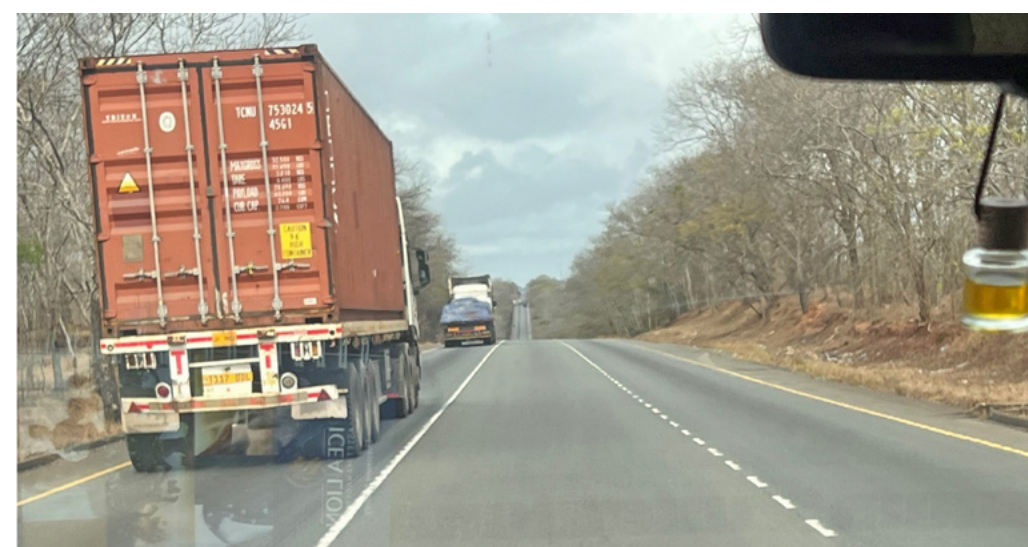
Figure 4: A section of the Dar es Salaam – Tunduma Trunk Road in Morogoro Region

This section of about 919km forms a part of the paved trunk roads network in the URT maintained and managed by TANROADS. The road surface condition was largely good with visibly clear road furniture and markings. Some road sections within the Mikumu National Park were under maintenance but wouldn't grossly interrupt traffic flow.

Generally, this section was wide enough with proper hard shoulders save for the 8km section within the high-altitude section between Mbuyuni and Ilula in Morogoro region in which the road was narrow and limited to a speed of 10km/h.

This section was observed to have seven weigh bridges, eight police checks, at least 23 traffic police stops. Rutting was observed between Uyole and Tunduma which slowed traffic. There was no clear railway level crossing signage at safe distance at Inyala which made it risky for road traffic.

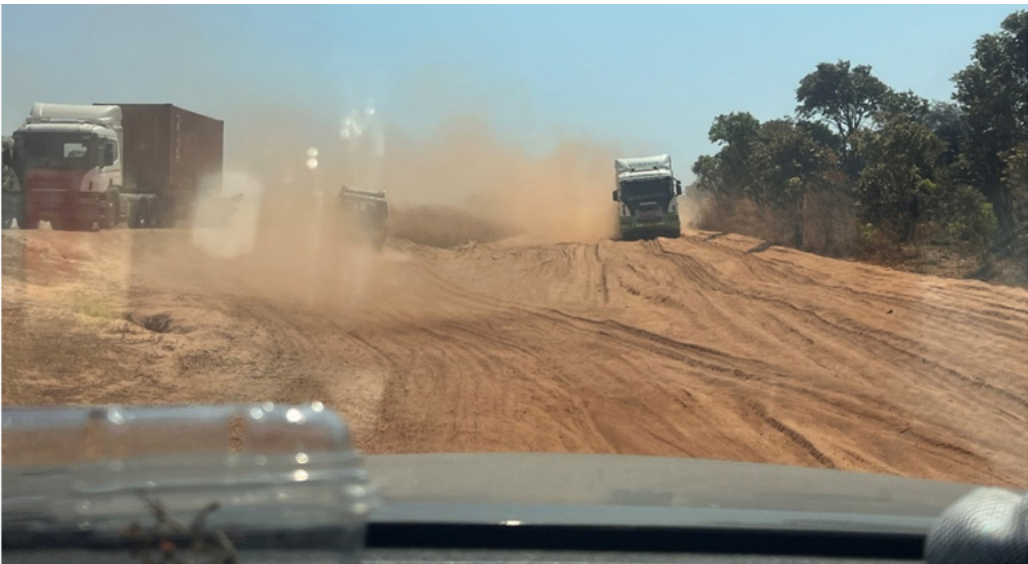
Figure 7: Shows One of the Damaged Sections along Mpika – Serenje road with Traffic Creating Bypasses

At least five accidents involving trucks were observed along the Nakonde – Mbala turnoff – Serenje stretch that were attributable to the condition of the road being bad. Due to the high levels of reported accidents on Zambian roads associated with the road condition, RTSA deployed two recovery (tow-away) trucks to help clear accidented vehicles off the road to avoid traffic jams.

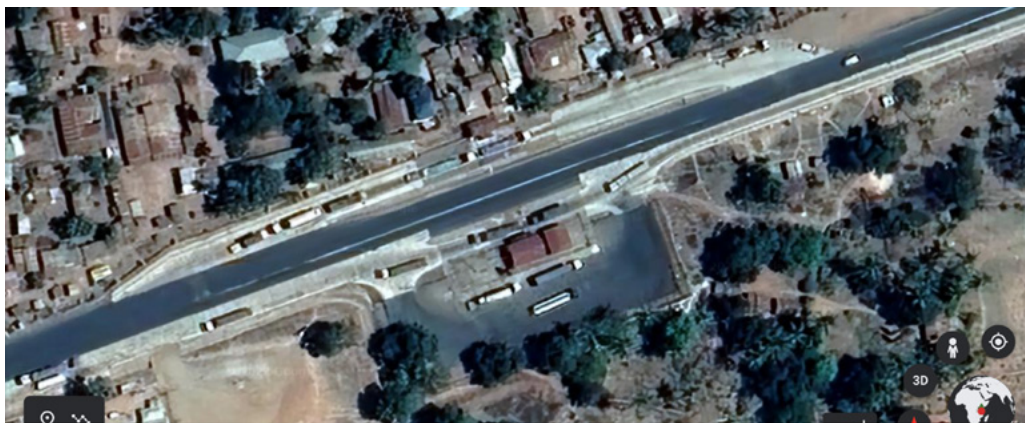
Figure 9: Google map showing Mikese weighbridge

Mikese was about 165km from Dar es Salaam had two weighbridges; Mikese 1 (for traffic from Dar es Salaam) and Mikese 2 (for traffic to Dar es Salaam) installed on either sides of the road respectively. There were sufficient lay-bys leading into the weigh stations that allowed traffic for weighing to get off the main road sections to avoid jamming general traffic.

Mikese 1 had a fixed single deck weigh-in-motion weigh bridge (weighing at 5-10km/h with only non-compliant vehicles stopped) with holding area of about 1,500m² for non-compliant vehicles while Mikese 2 operated a single deck static weigh bridge. The combination of operating a weigh in motion weigh bridge, having adequate lay-bys and holding area ensured that there was no traffic jam at the weigh station.

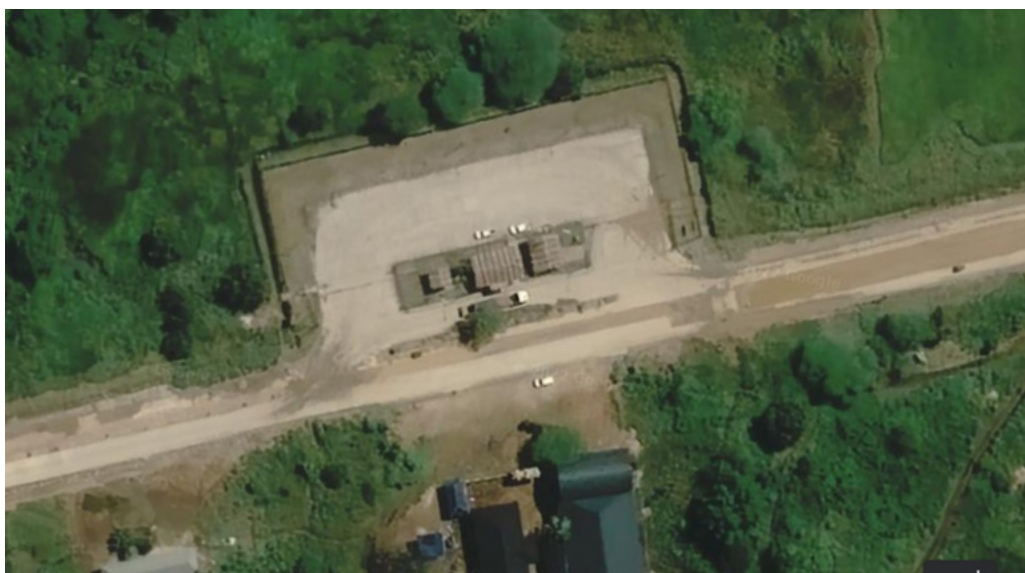
Figure 10: Google map showing Mikumi weighbridge

This weighbridge station was found within the Mikimu National Park around 300km from Dar es Salaam installed with a single deck fixed and static weigh bridge. About 550m east of the weighbridge, there were lay-bys on both sides of the road measuring about 650m on each side.

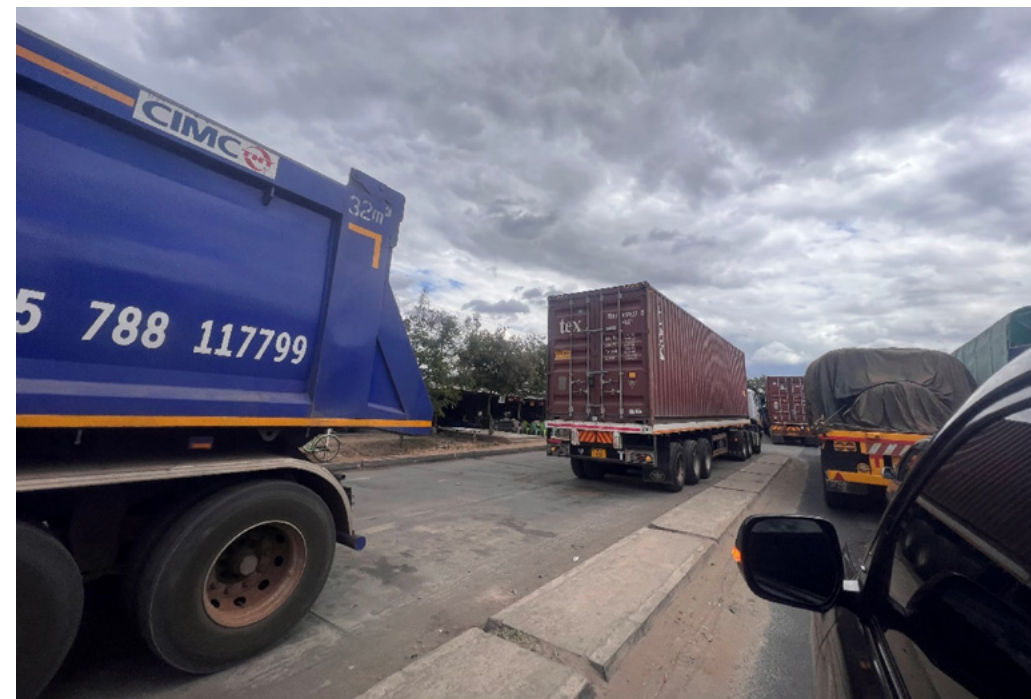
These were useful for truck drivers to rest but also helped regulate traffic flow of trucks from the Dar es Salaam direction which ensured no congestion at the weighbridge. However, due to the weighbridge being located on side of the road, there was traffic congestion stretching about 700m from the weigh station largely caused by right turning vehicles accessing the weighbridge.

Figure 11: Congested approach to Mikumi weighbridge

The station had a holding area of about 3,000m² capable of holding up to 50 noncompliant vehicles at once to verify their axle load compliance.

- i) Tanzania and Zambia to expedite the harmonisation of permissible vehicle dimensions and attributes to eliminate discriminatory limitations;
- ii) The installation of weighbridges on both sides of the road at a weigh station to avoid right U-turns to access the weighbridge on the opposite side of the road especially at busy stations handling over 1,000 vehicles a day like Kapiri Mposhi and Kafulafuta which are found on a trunk road with an Annual Average Daily Traffic (AADT) of between 3,000 – 5,000 majority of which are trucks;
- iii) Replace all single deck weighbridges with multideck ones (preferably with weigh in motion capabilities) at stations where the daily registered traffic was above 500 vehicles. This was the case with all surveyed stations.

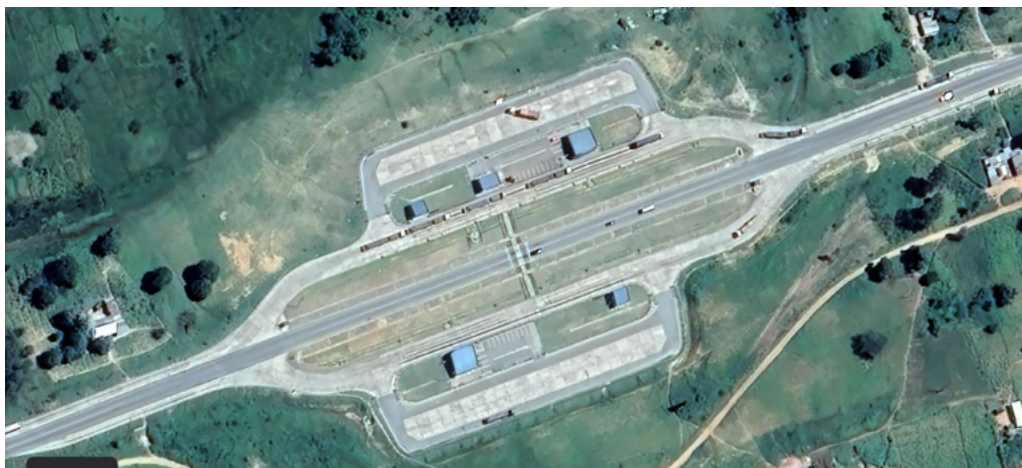
Found in Iringa region at Wenda, the Tanangozi weigh station had two fixed, single deck and static weighbridges one on each side of the road. The station had two lay-bys were about 400m long on both sides of the road with about 3,300m² of paved holding/parking space for non-complying vehicles on each side.

No major issues were reported at this weighbridge during the survey and there was free flow of traffic with each vehicle taking about two minutes to exit the weigh station from the time it lands on the weighbridge.

Figure 12: Google map showing Tanangozi weighbridge

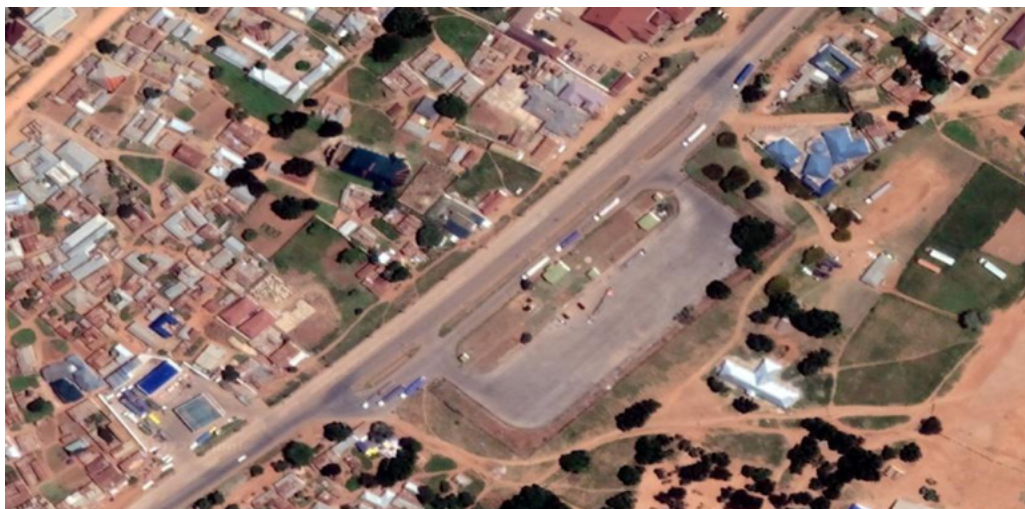
Mbemba weighbridge station was located 10km from Tunduma border crossing installed with a fixed single deck static weighbridge. The station had one weighbridge installed on the side towards Tunduma having a holding area of about 6,200m² and a combined lay-by length on both sides of about 700m. Vehicles from the border had to cross the road to access the weighbridge sometimes holding back other traffic for considerable times.

Figure 13: Google map showing Mpemba weighbridge

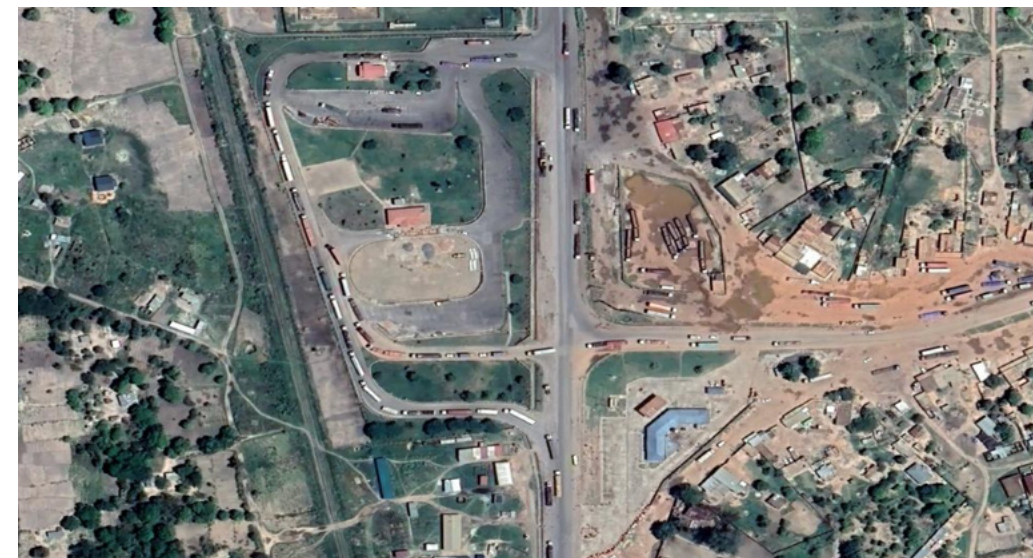
Figure 14: Google map showing Kapiri Mposhi weighbridge

Kapiri Mposhi weigh station was located at the junction of Serenje – Kapiri Mposi road and Kabwe – Ndola Road on the left side of the Kabwe – Ndola road. It had a fixed, static and multideck weighbridge installed. It had an advance lay-by of about 200m from the Kabwe direction with sufficient circulation and holding areas for vehicles with questionable axle loads.

There was noticeable traffic jam around the junction partly caused by traffic from Ndola making a right turn to enter the weigh station and traffic from Serenje crossing the main Kabwe – Ndola road to enter the weigh station.

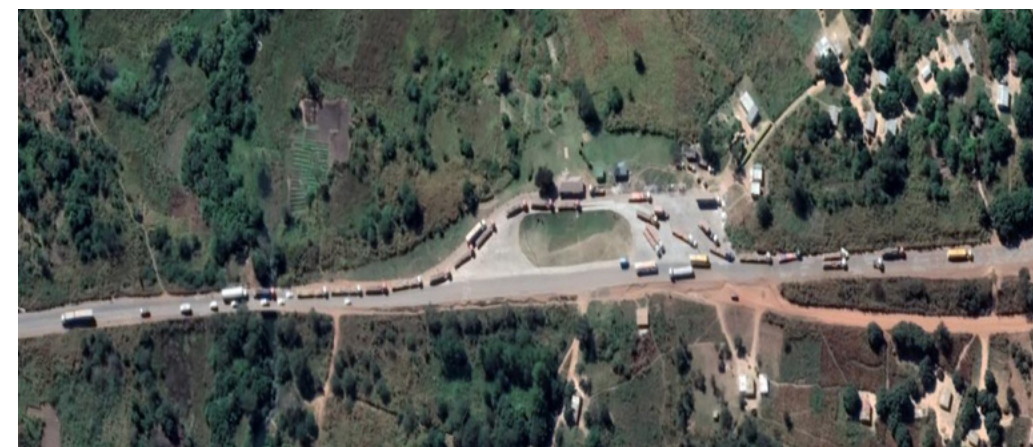
Figure 15: Google map showing Kafulafuta weighbridge

Kafulafuta was a fixed, static single deck weighbridge located at Masaiti between Kapiri Mposi and Ndola, about 79km from Kapiri Mposhi in Zambia. The weigh station was off the main trunk but didn't have an entrance lay-by off the 7.5m standard two lane busy highway which predominantly causes queuing back into the road which causes massive traffic jams to general traffic.

There was a small holding area of about 900m² at the exit of the station for vehicles with pending issues to sort with the station. The location and size of the holding area was seen to be obstructive to traffic exiting the station.

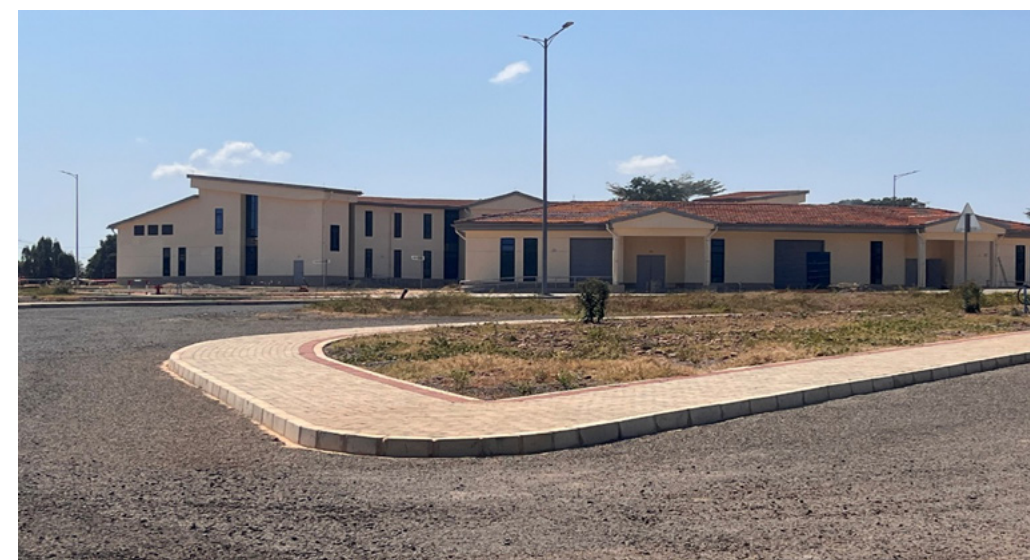
By the time of the survey, Tanzania had progressed with the construction of the OSBP facility (including the installation of a container scanner, cargo inspection and destuffing areas, passenger and truck clearance terminals) with completion timelines set for December 2022 yet Malawi was reportedly still acquiring land.

Figure 16: OSBP Under Construction on Tanzanian Side Kasumulu Border at 98% Completion

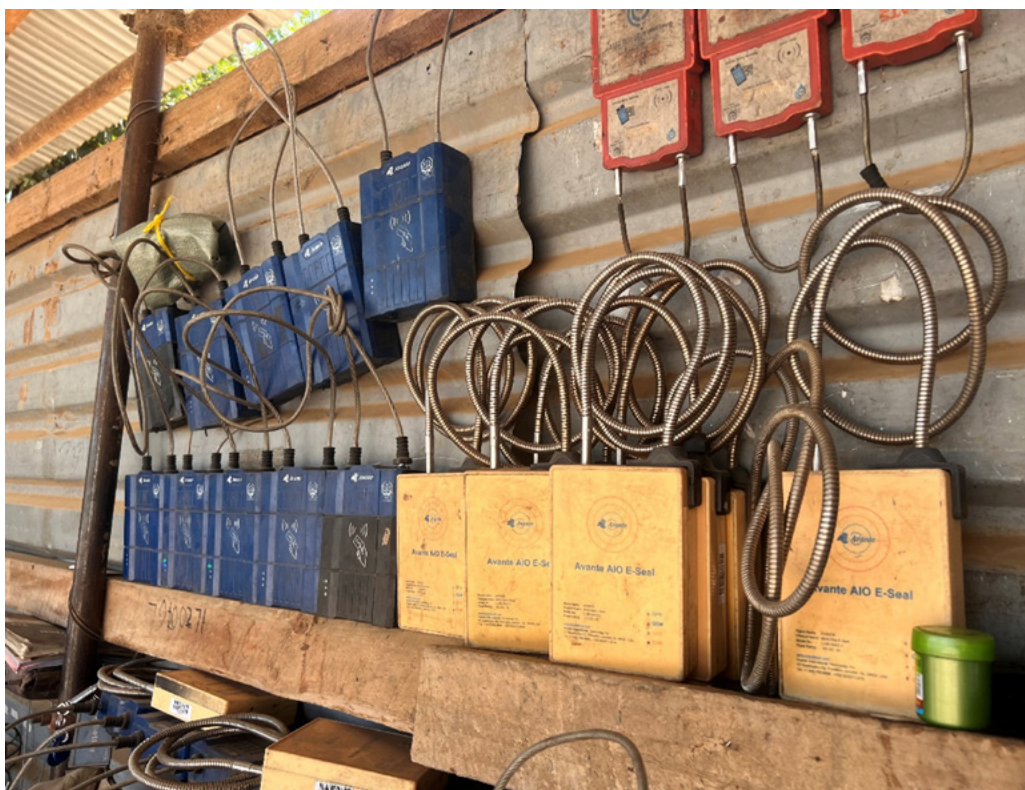
TRA disarmament of the E-seals on transshipment cargo would be done at the border crossing after a physical inspection and exit clearance had been granted.

Figure 17: Disarmed E-Seals at Kasumulu border crossing

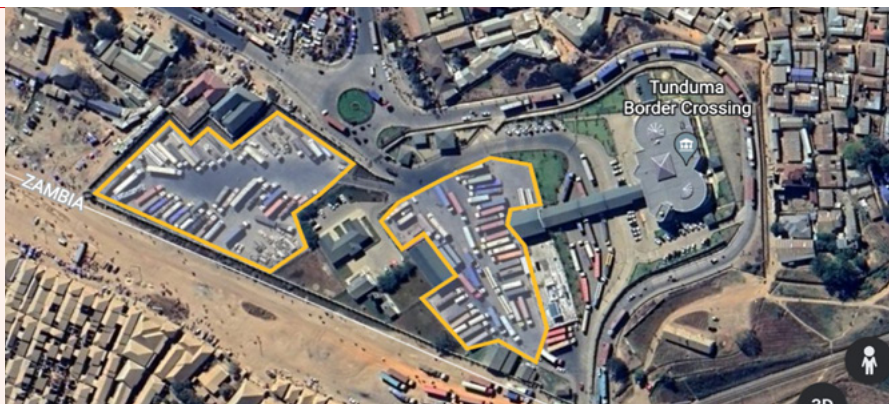
- i) TRA received and processed all cargo trucks and vehicles from Zambia 24/7 with a few that had pending customs issues held at designated customs areas in Mpemba. There was also space capable of holding up to 100 trucks/buses and over 50 small vehicles as they were being processed through the border;
- ii) Both exiting and entering traffic had different roads which helped reduced potential traffic congestion;

Figure 18: Google map showing Tunduma OSBP with Parking Yards Highlighted

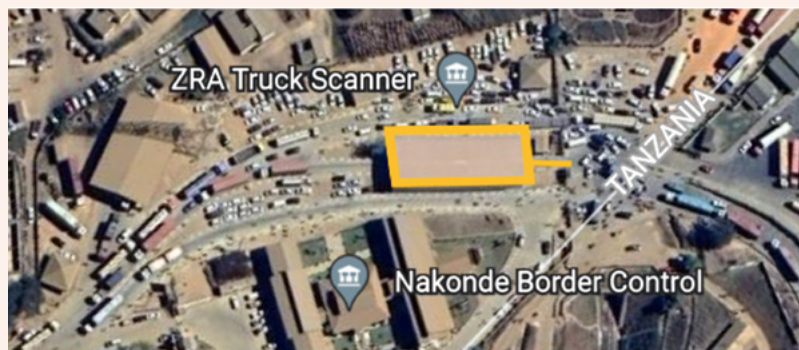
- i) ZRA could only process container trucks between 0800hrs – 2000hrs with the rest of the cargo received at night save for explosive cargo that would be given priority. This meant that the rest of the trucks had to be held at Mpemba, Tanzania till they were called upon;
- ii) There was no holding area for vehicles as clearance was being done, this caused unnecessary traffic jam at the border with a designated parking for trucks located 10km away;
- iii) Both passengers and trucks were being cleared in the same facility which caused human congestion and confusion;

Figure 19: Google map showing Nakonde OSBP with Container Scanner Highlighted showing how close it was to the main road

- iv) Both incoming and outgoing trucks and vehicles under customs (imports, exports and transshipments) used the same road which caused traffic congestion;

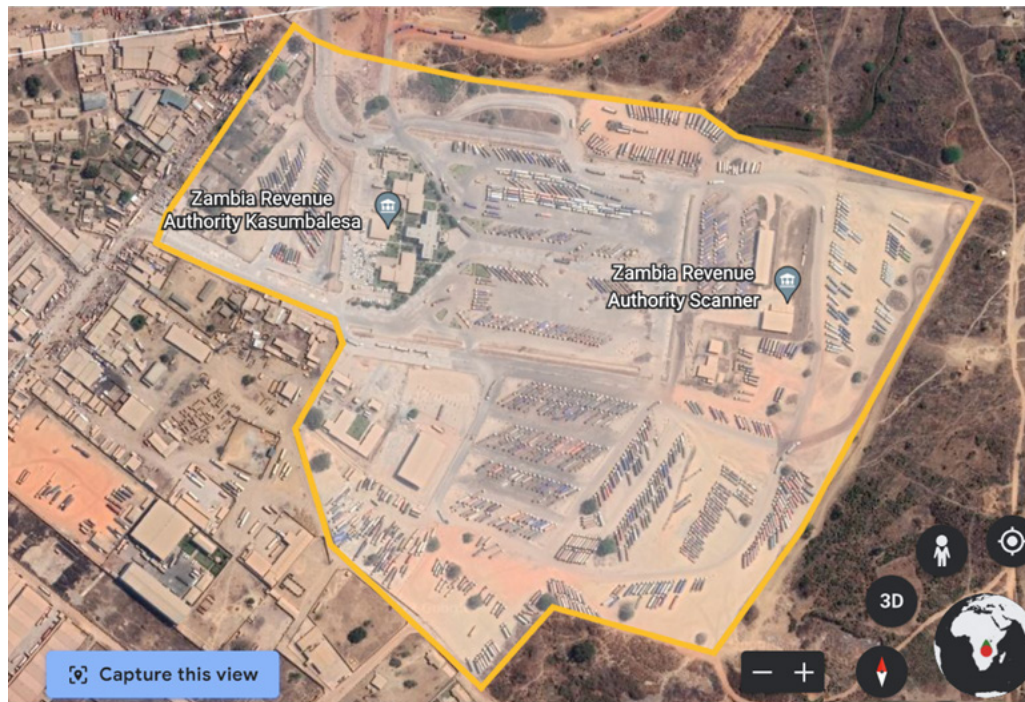
Figure 20: Google Map showing the Border facilities under ZipBCC

On the Zambian side, border infrastructure (office spaces, parking and associated road infrastructure from the gates, installation of ICT equipment) were constructed by ZipBCC under a Design, Build Operate and Transfer arrangement granted by the government of Zambia. Construction of the border post was completed and operations launched in March 2011. Traffic management within the border crossing facilities was also under ZipBCC.
